THE CAUSE OF  
EROSION IN THE  
FINNEY FARM AREA

By Kerrie E. Neet

June 7, 1984

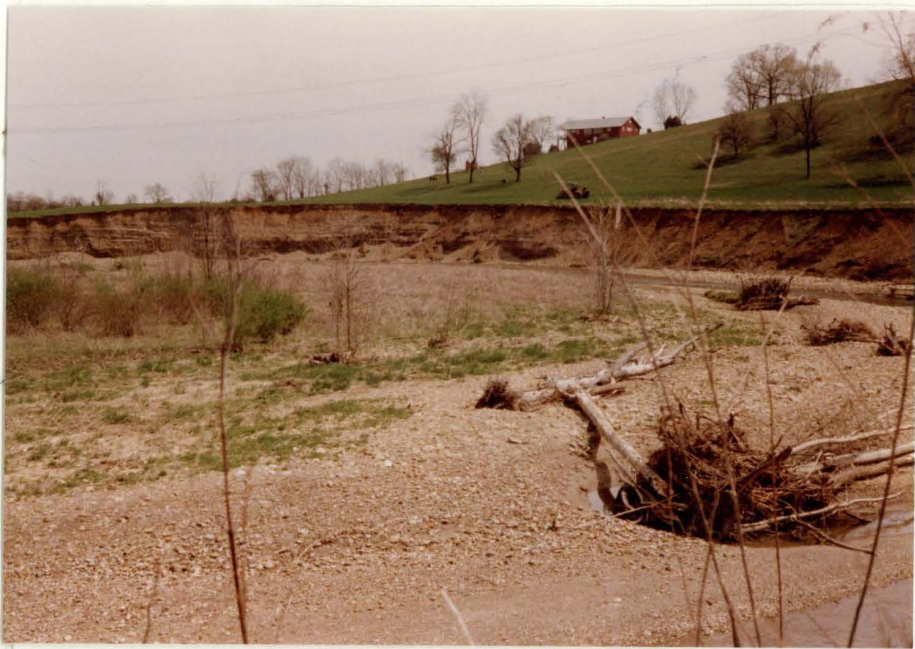
Figure 1. The river bend of Dry Creek where erosion of the Finney Farm has occurred. View is upstream of the farm.

Dry Creek in Licking County is an area where change has occurred and a geomorphic threshold has been reached (Figure 1). The changes seen in the Finney Farm area and downstream from it have been dramatic in the last twenty years. Between 1976 and 1983, the difference between the elevation of the stream and the high point on the bank increased ten feet and the meandering of the stream destroyed 2.02 acres of Finney's property with 0.14 of those acres prime agricultural land (Finney, 1983). If Dry Creek continues its destructive course, the housing area across the stream may also be endangered (figure 2).

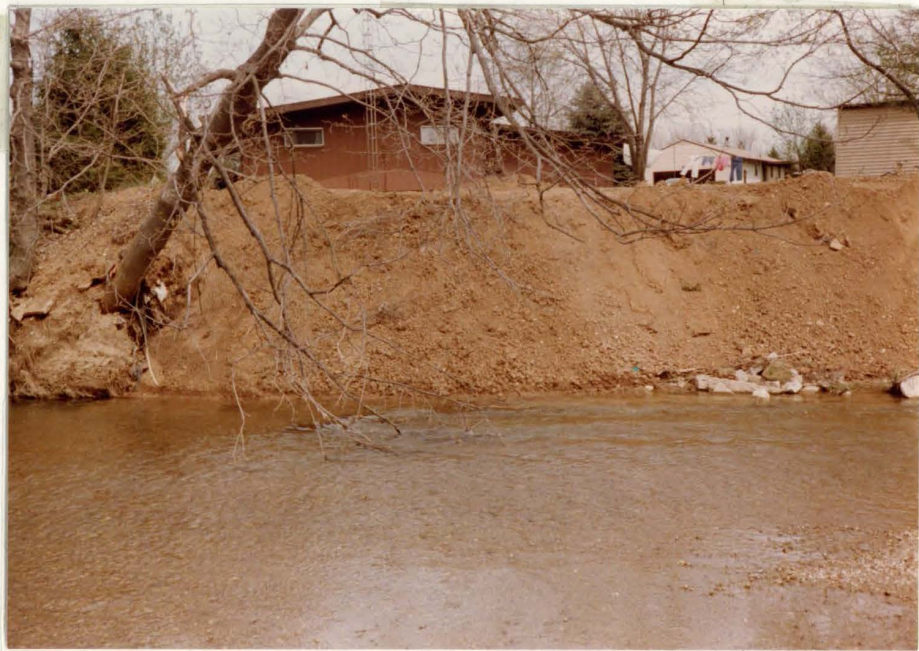
Figure 2. The housing establishment upstream and across the river from the big bend. If erosion by Dry Creek continues at its present rate, this person may lose his house in another ten years.

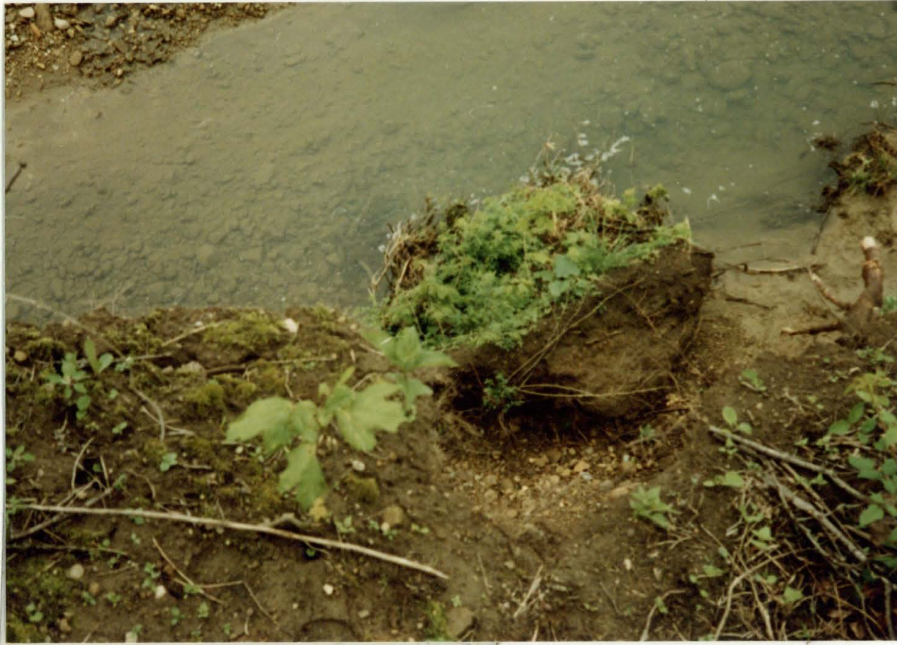
Figure 3. Evidence of mass movement occurring on the Finney property due to high infiltration capacity in noncohesive, well-sorted glacial outwash.

Dry Creek in the Finney Farm area is cut into a glacial outwash terrace of Wisconsinian age. This outwash has a silt cap of two to three feet and is well-sorted. Because the topography has low relief it is not very influential in the erosion of the Finney property. Rill and gully erosion is also minimal because of the high infiltration capacity of glacial outwash. Glacial outwash, however, is conducive to some erosion processes. Mass movement tends to occur in outwash terraces because the erosion process does not have to overcome cohesion between the grains. Evidence of mass movement is seen in the Finney Farm area (Figure 3).

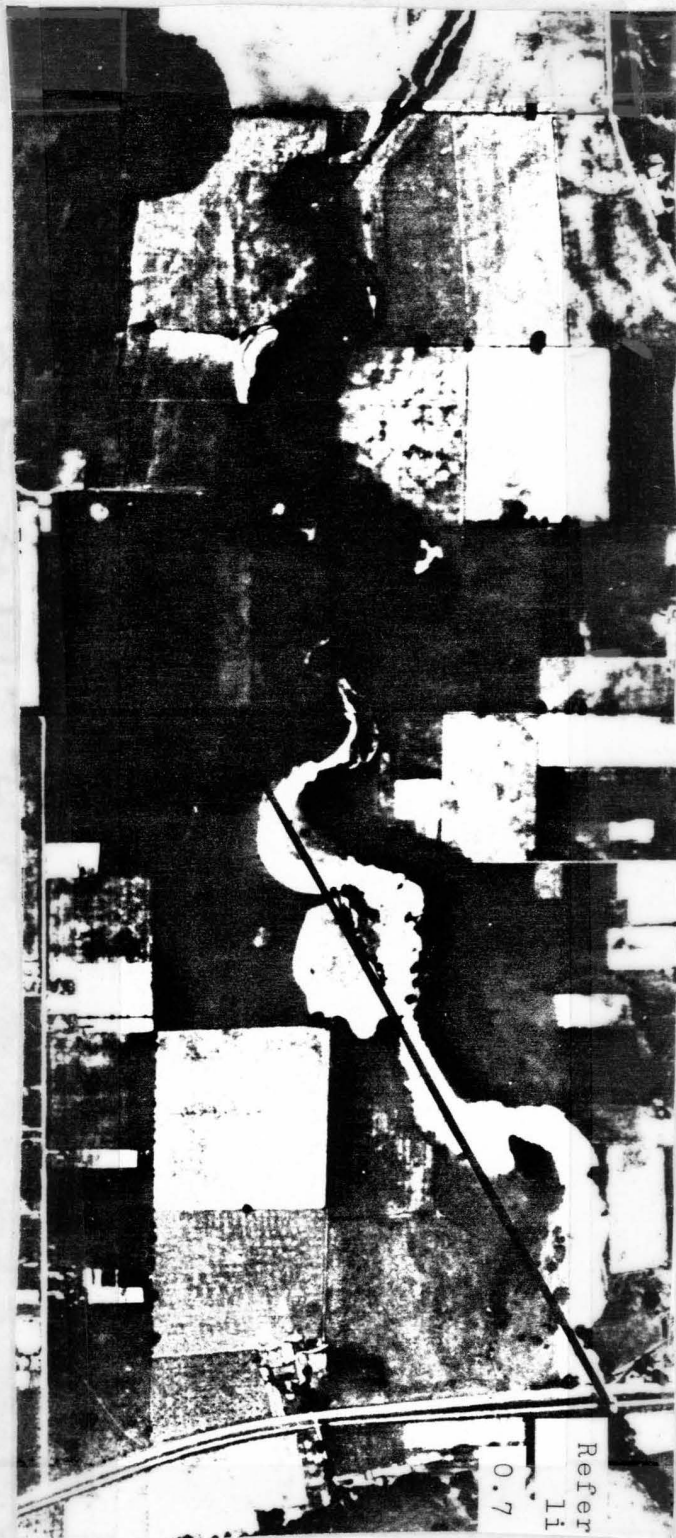
Figure 5. Aerial photograph of Dry Creek taken on 7-14-40 (by Henderson Surveys Inc.).

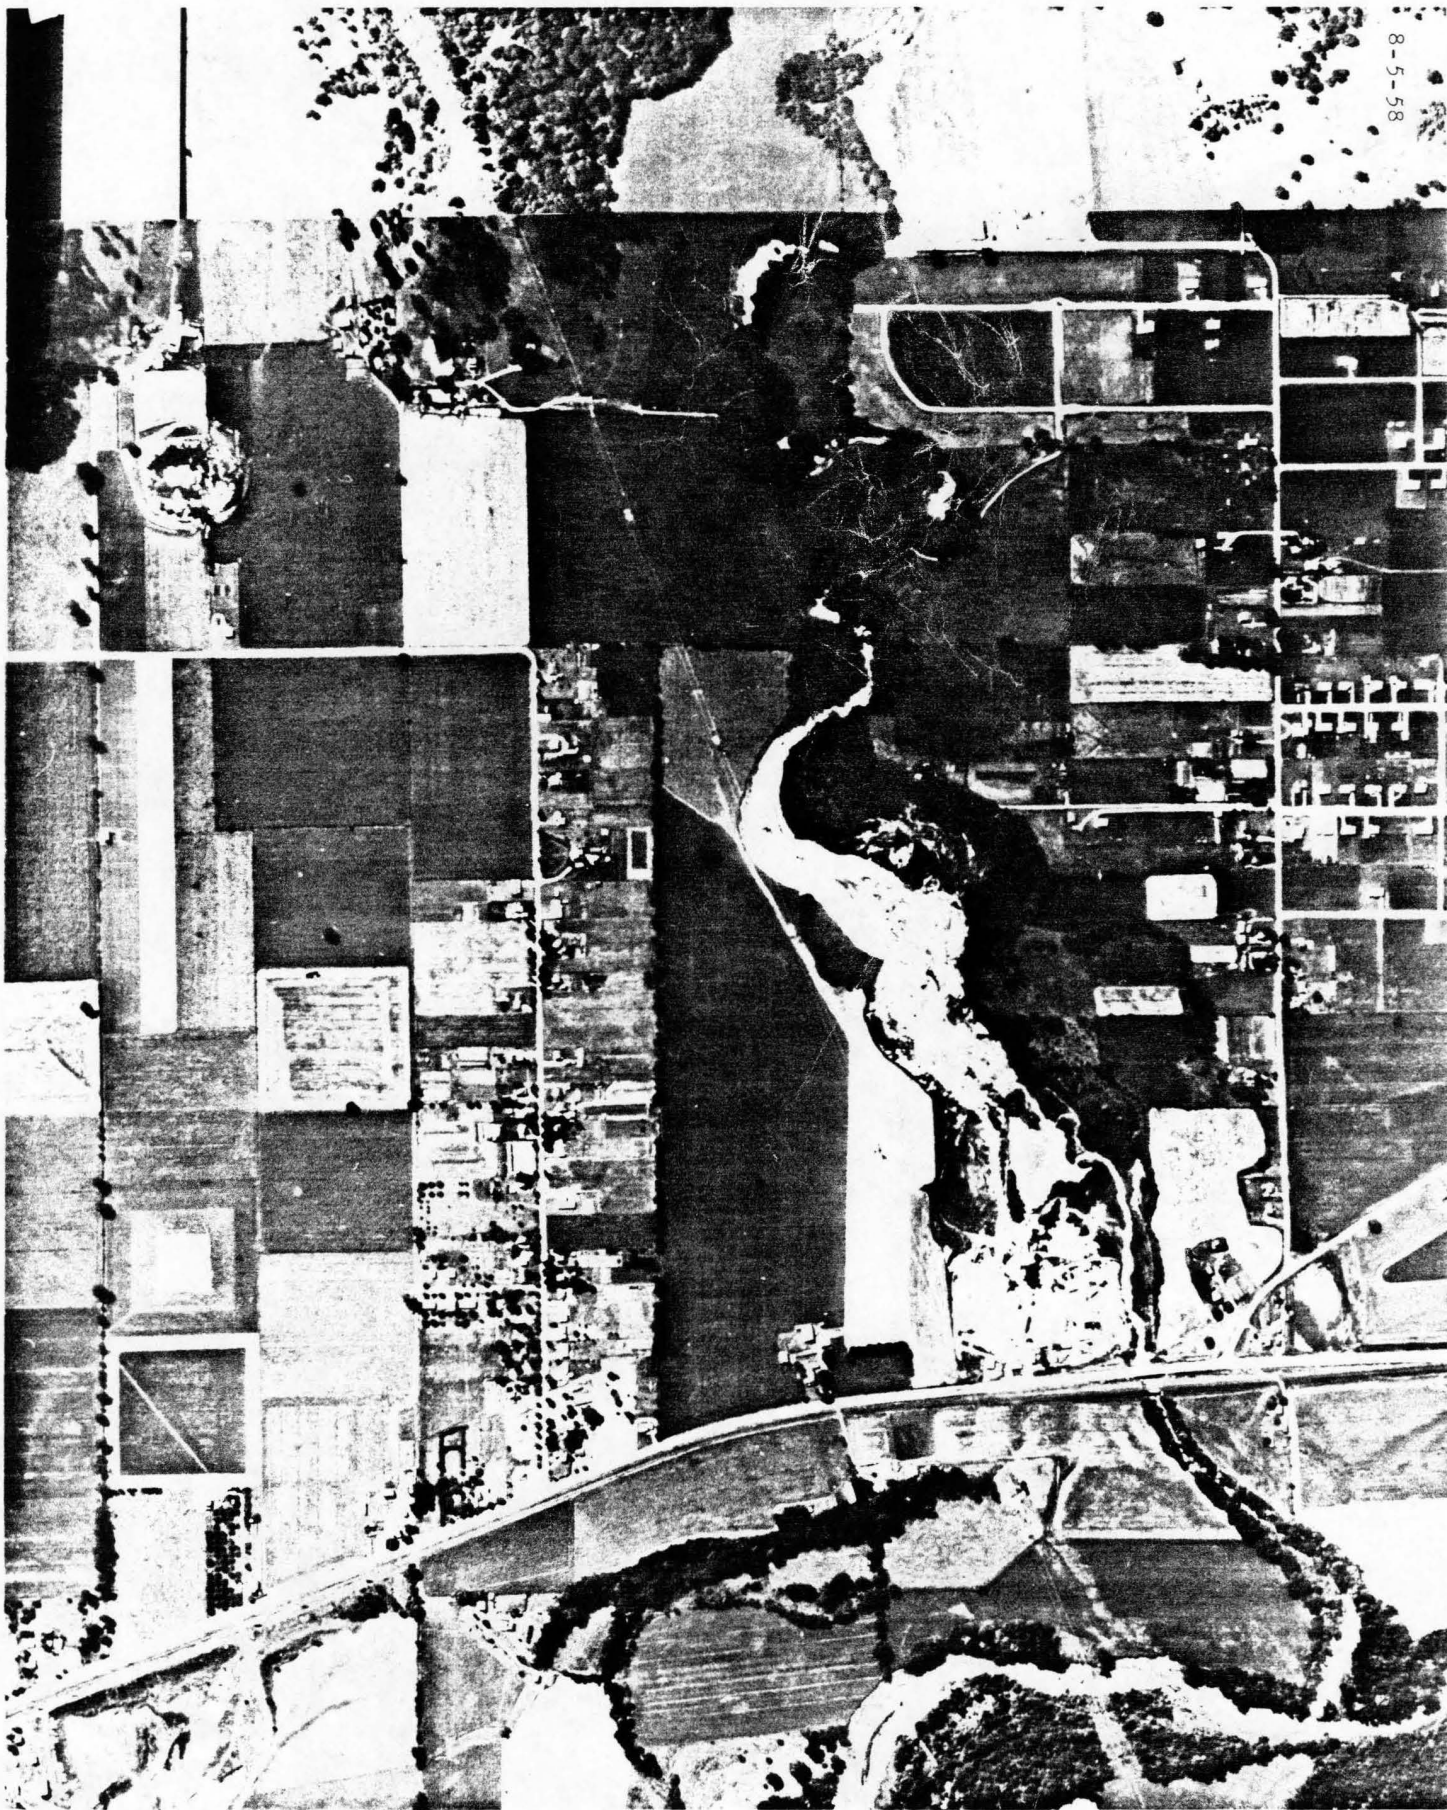
Figure 6. Aerial photograph of Dry Creek taken on 8-5-58 (by Henderson Surveys Inc.).

on the Finney Farm, but downstream point bar enlargement is apparent. The change in enlargement and instability downstream is even more evident in the 1958 view (Figure 6). This view of the river downstream suggests that a geomorphic threshold has been reached since the nature of the stream has changed from meandering to braided (Schumm, 1973). In the 1964 view we first begin to see a change in the Finney Farm big-bend; the point bar is enlarging (Figure 7). This new change shows that degradation is migrating upstream. From the view taken in 1964 to the view taken in 1970 a significant change has occurred (Figure 8). The two meanders directly downstream from the Finney Farm have been cut-off and the rate of degradation and instability seems to have increased. The 1970 view to the 1983 view shows the greatest degradation and instability in the Finney Farm area with the downstream reaches beginning to stabilize (figures 8, 9, 10, and 11).

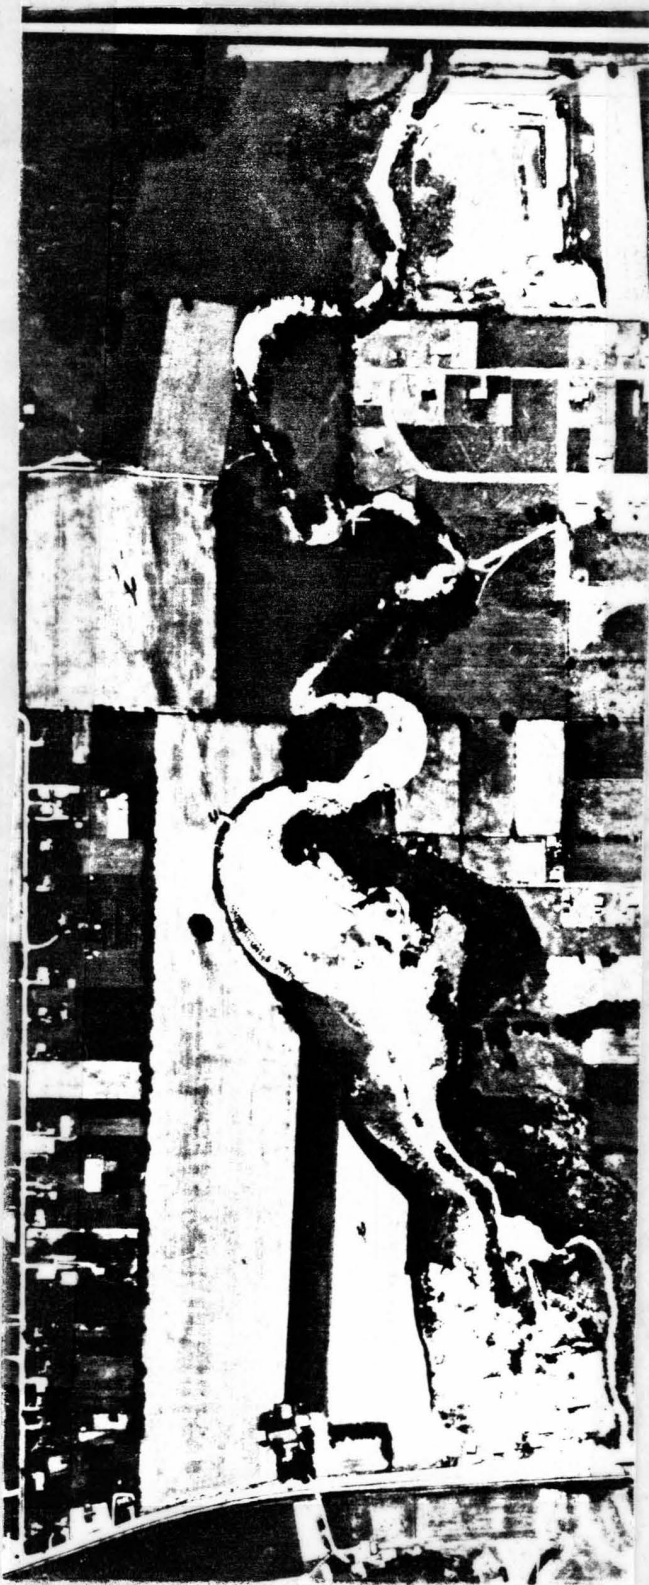
Figure 7. Aerial photograph taken in 1964 by Henderson Srveys Inc. The point bar on the Finney property is enlarging.

The Cut-off of Meanders. The cut-off of two meanders directly downstream from Finney Farm occurred sometime between 1964 and 1970 (see Figures 7 and 8). According to Galay (1983) the creation of a cut-off causes a decrease in river length and a local increase in slope. Because of an increase in slope, higher flow velocities and greater sediment transport will result and upstream degradation will occur. This increase in velocity and sediment transport probably occurred at Dry Creek because slope increased from .00448 feet per foot to .0073 feet per foot from 1962 to 1983 (Finney, 1983). Therefore, the cut-offs are probably partially responsible for the degradation occurring at the big-bend of Dry Creek near Finney Farm.

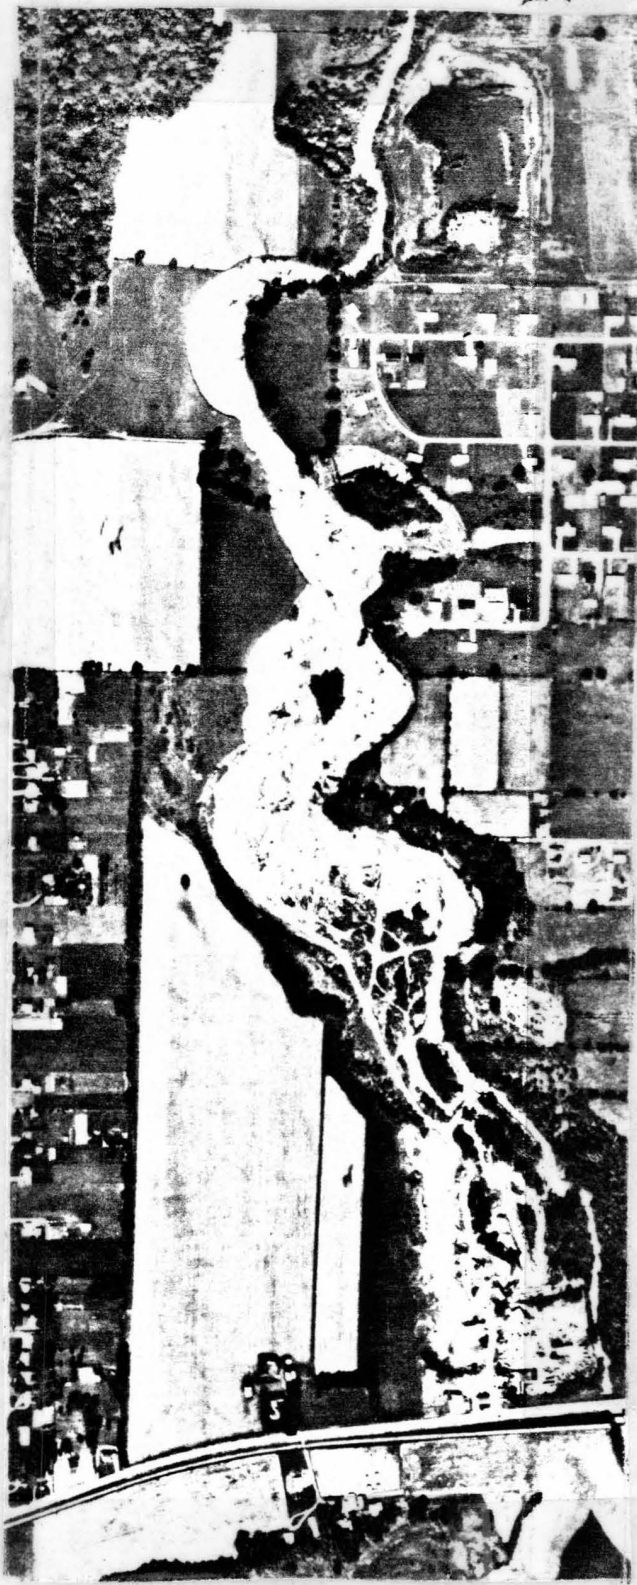
Figure 8. Aerial photograph taken in 1970 by Henderson Surveys Inc. Notice the cut-off of the two meanders that occurred since 1964.

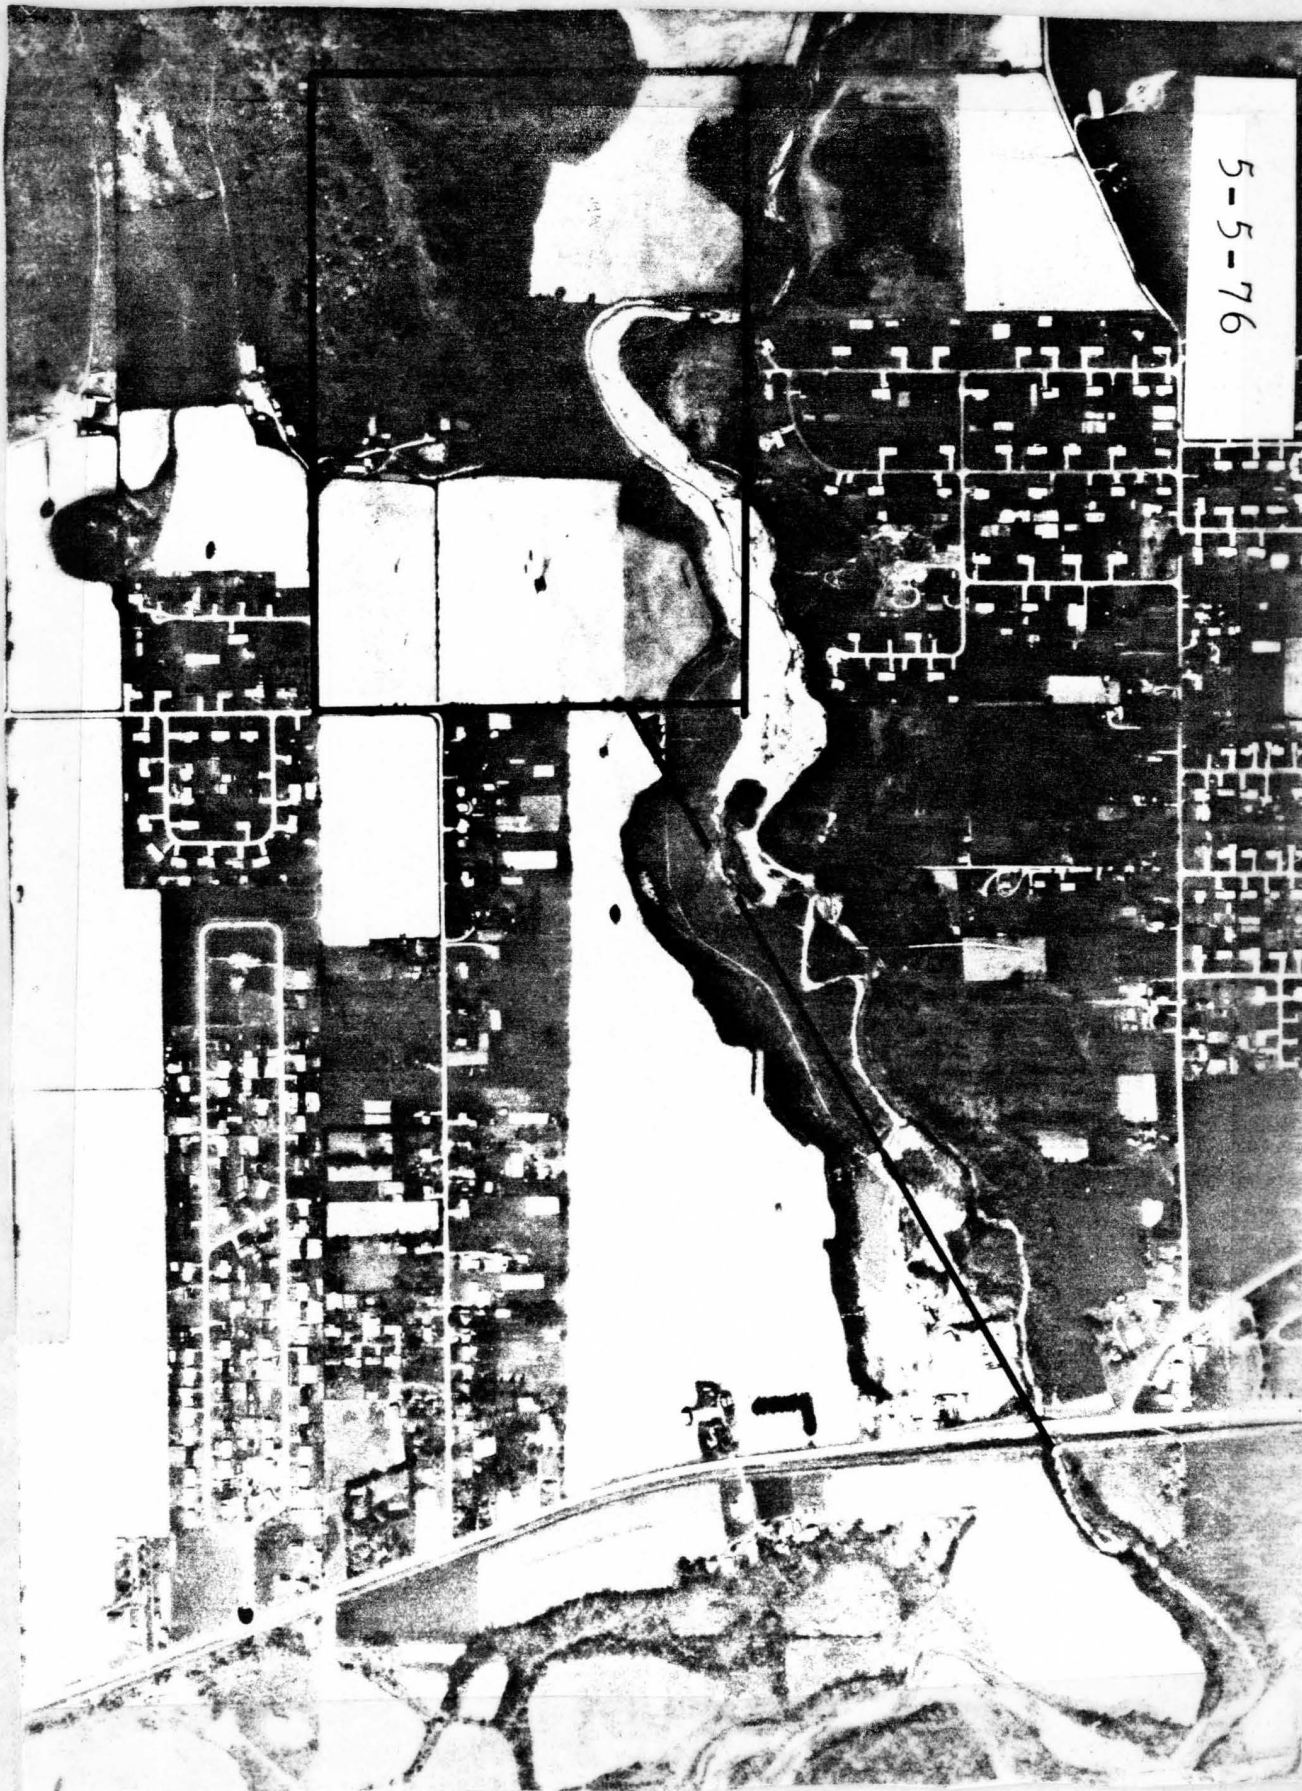
5-5-76

Figure 9. Aerial photograph of Dry Creek taken in 1976 (by Henderson Surveys Inc.). Notice that the downstream reaches from Finney Farm are beginning to stabilize.

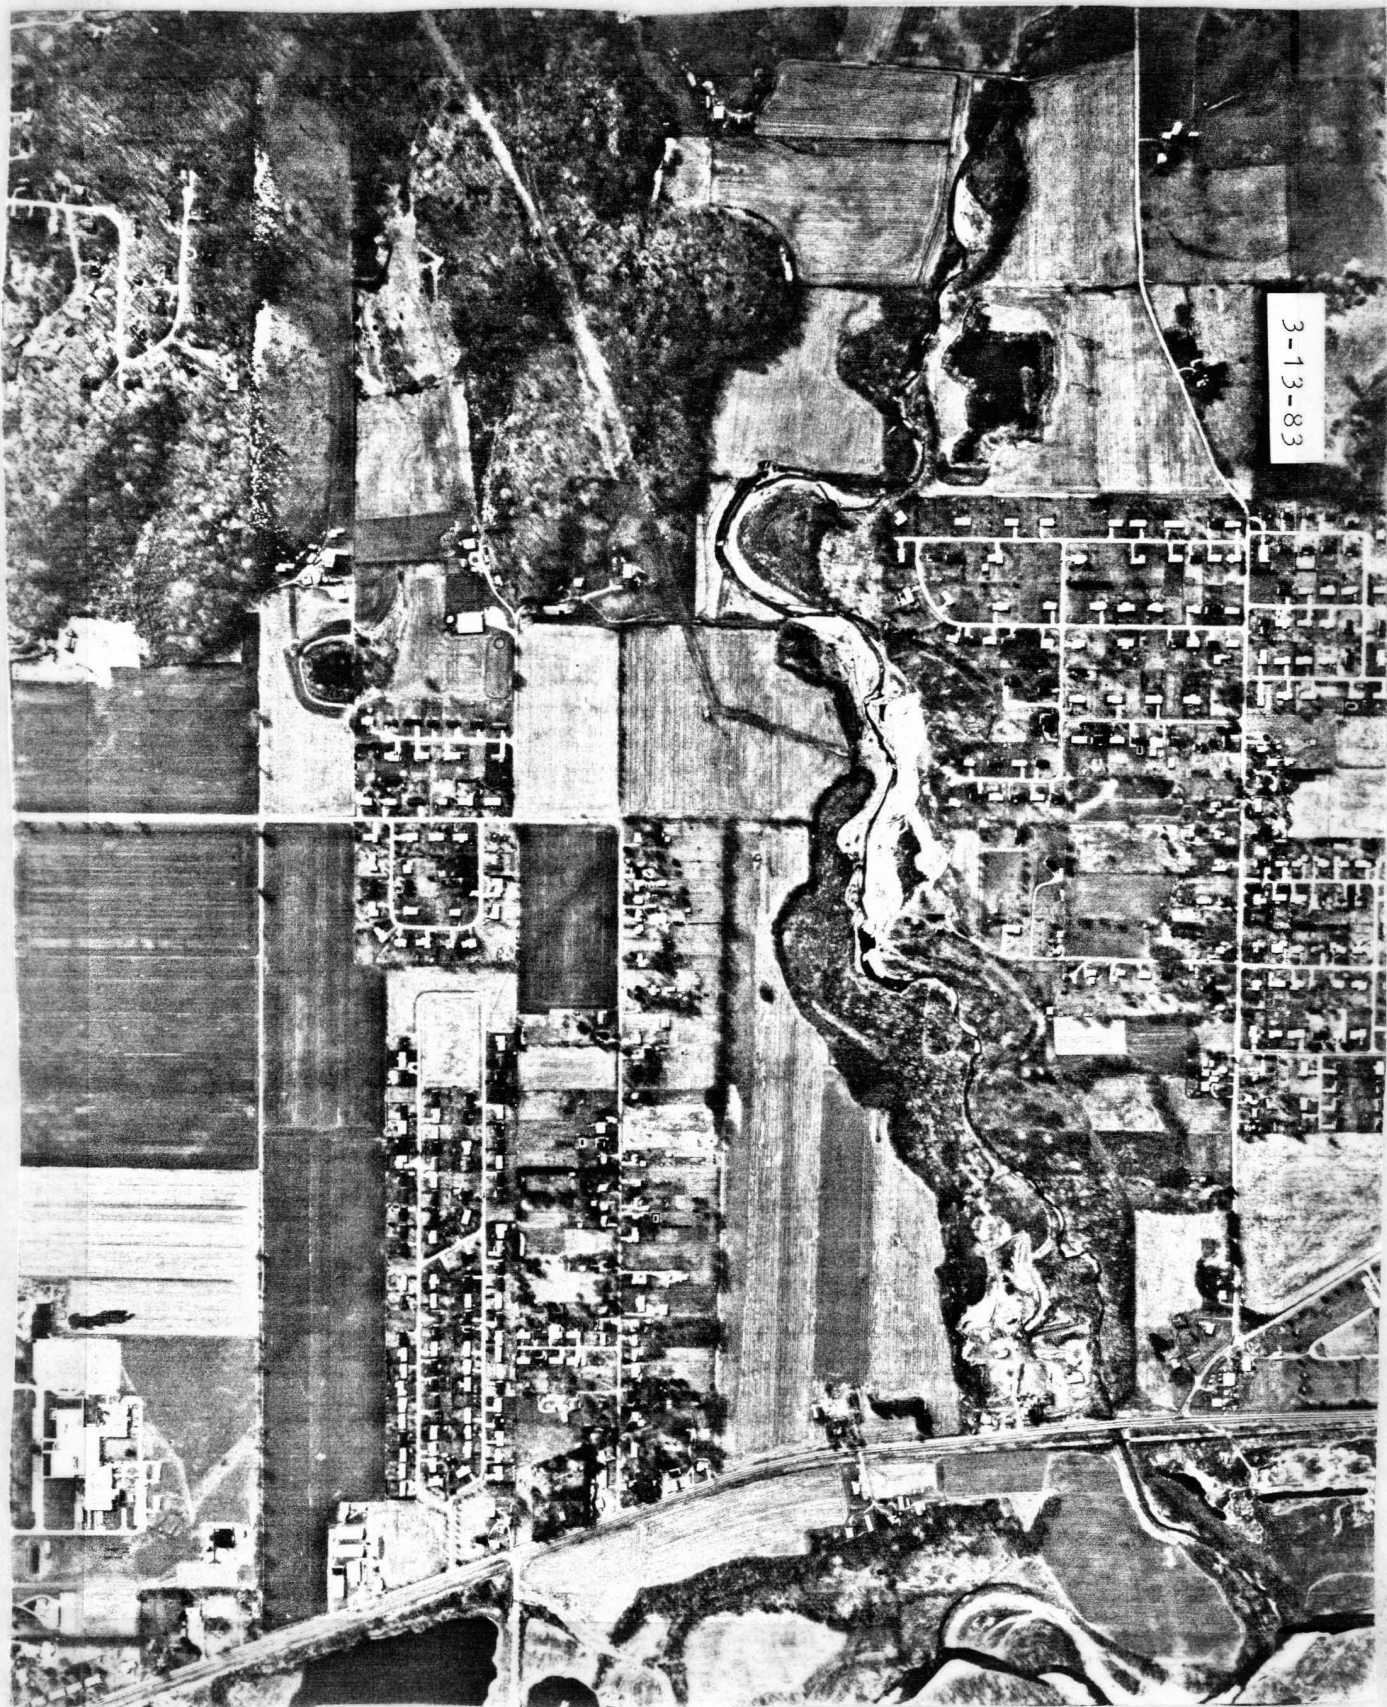
Figure 11. Aerial photograph of Dry Creek taken in 1983 (by Henderson Surveys Inc.). Maximum degradation is now occurring in the Finney Farm area.
